Office of Transport Safety Investigations

BUS SAFETY INVESTIGATION REPORT

FATAL COACH ACCIDENT

BARRENGARRY NATURE RESERVE

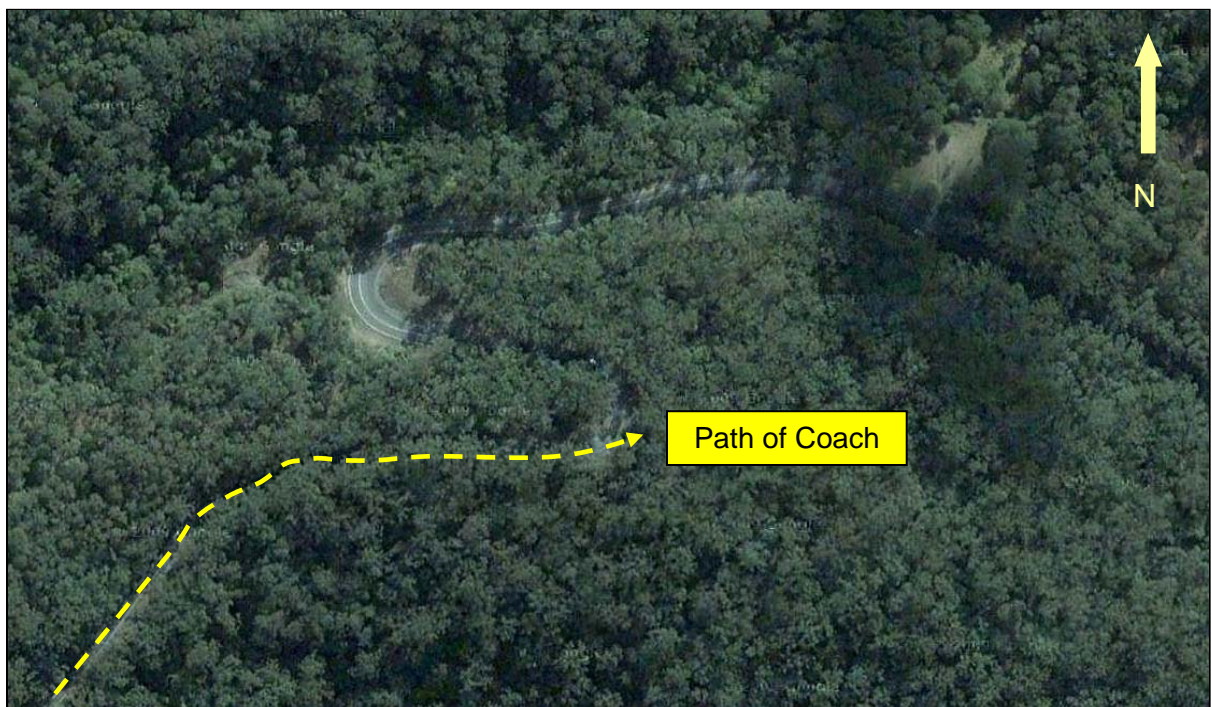
Photograph 1: Aerial view of accident site

- 1.4 Main Road 79 is known as Nowra Road as it passes through Fitzroy Falls, and then becomes Moss Vale Road as it heads South East towards Kangaroo Valley. It is a two-way sealed road linking the Southern Highlands with the coast, and is classified by the NSW Roads and Traffic Authority (RTA) as a Main Road. The accident site is in an area surrounded by dense bushland within the Barrengarry Nature Reserve. The area is mountainous and there are long steep descending gradients in several locations throughout the district.
- 1.5 Approximately 4km to the South side of Fitzroy Falls there is a long descending gradient for approximately 7km. The accident occurred towards the downhill end of this long gradient on the second last hairpin bend (see *Photograph 1*).

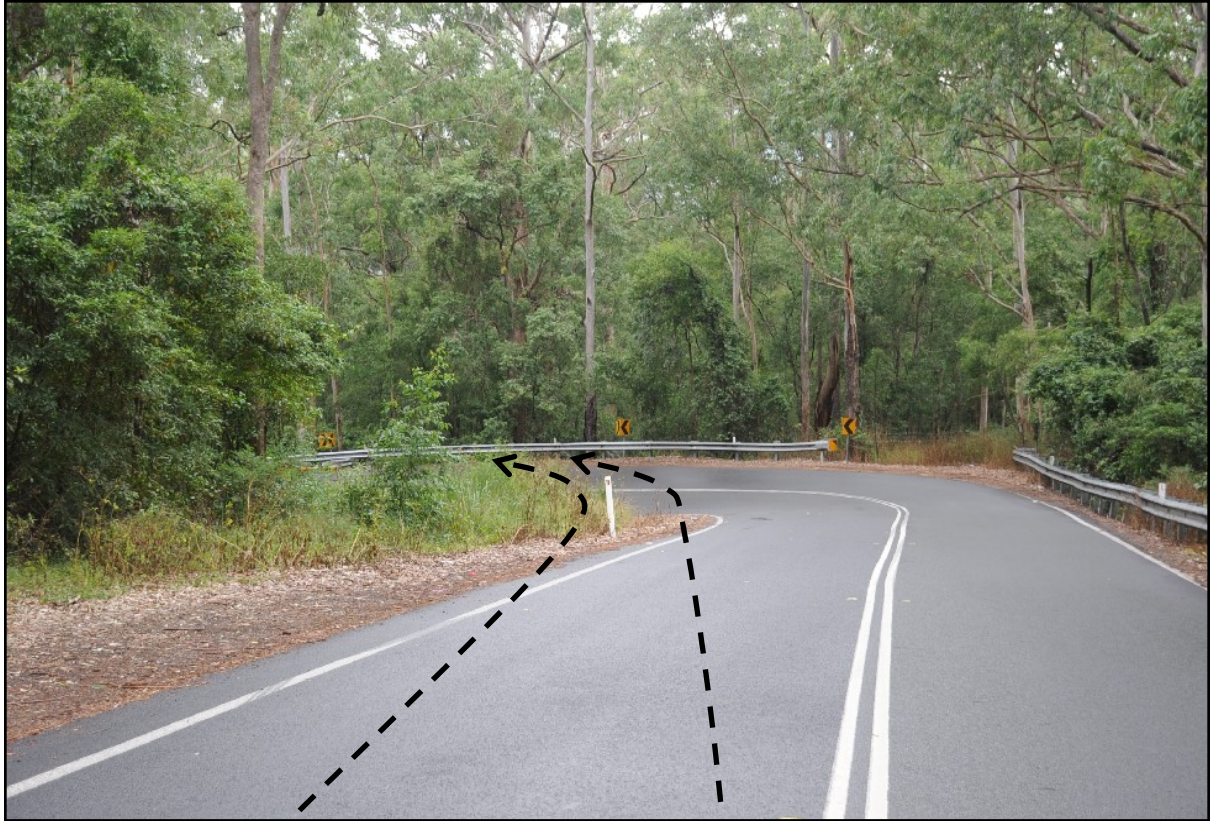
Photograph 2: The coach's pathway prior to the accident site

- 1.9 Marks found on the roadway and on the left-hand verge indicate that the driver had tried to negotiate a sharp left hand curve, signposted with an advisory speed of 25km/h. However, as illustrated in *Photograph 2*, the bus continued across the road, crashing through the guard rail and over the embankment, finally coming to rest in an upright position some 40m from the road. As the bus crashed down the embankment, the driver was thrown from the vehicle and sustained fatal injuries.

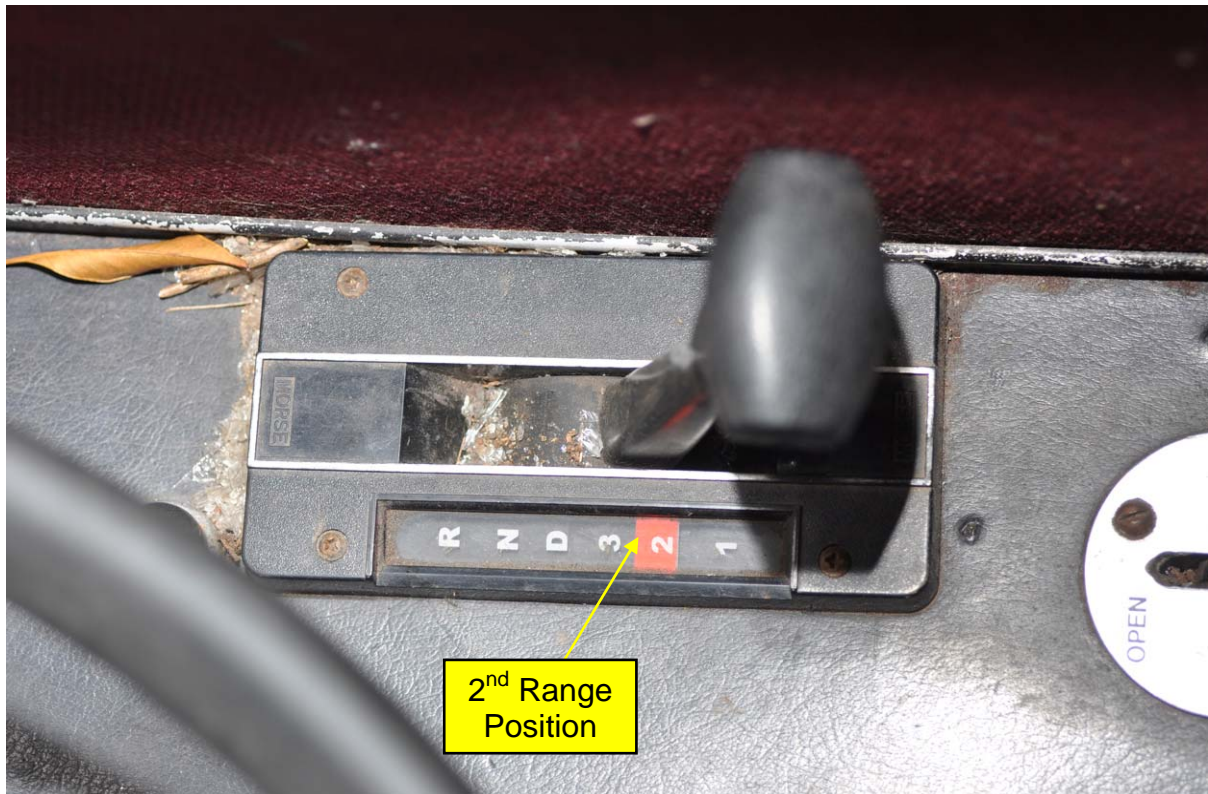
Photograph 3: Position of range selector

- 1.10 At the crash scene, the gear selector in the bus was found to be in the 2nd range position as shown in *Photograph 3*, and the front brake drums were extremely hot and discoloured. When the bus was winched back onto the roadway, the rear wheels were observed to be rotating freely, indicating that the spring brakes were ineffective.

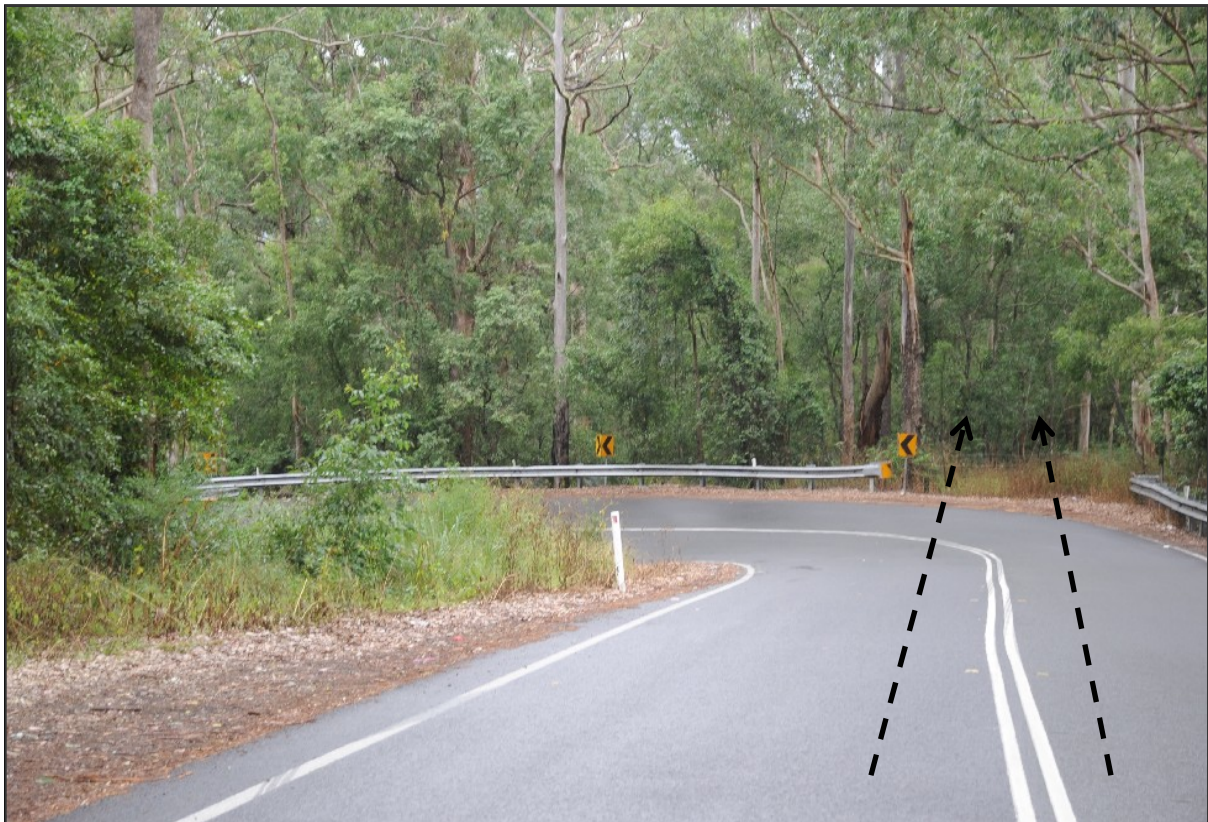
Photograph 4: Possible escape route

1.19 On 18 May 2010, OTSI investigators revisited the site of the accident in daylight. It was noted that, directly adjacent to the accident site, the terrain was level with a slightly falling gradient and sparsely treed bushland (see *Photograph 4*). If this had been known to the driver, it could have provided a safe runoff as an alternative to trying to negotiate a tight (25km/h advisory speed) bend at speed.

- examines the feasibility of installing an arrester area suitable for both heavy and light vehicles adjacent to the accident location.
- 3.3 It is also **recommended** that the **NSW Roads and Traffic Authority** and the **Department of Transport** review the opportunities or existing systems in place to exchange information on buses that are defected as part of the twice yearly HVIS inspections, with a view to providing information to target compliance activity.

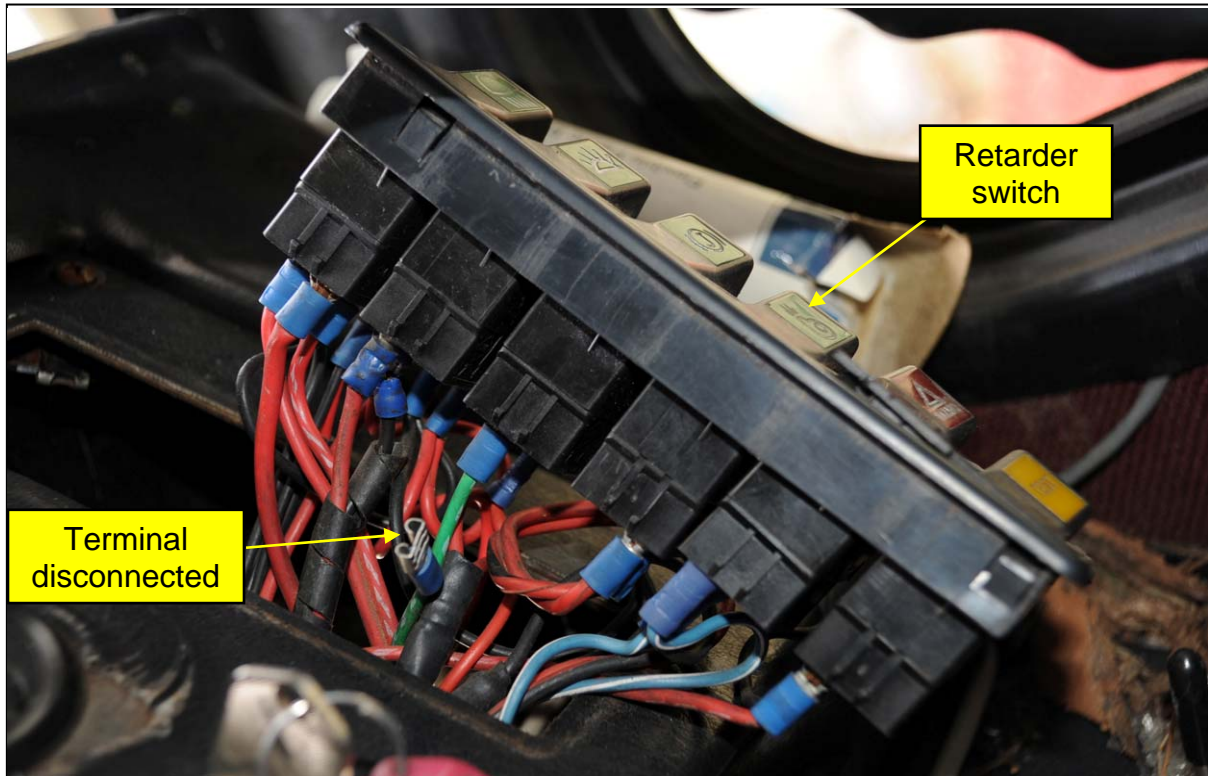
Photograph 5: Retarder switch disconnected

- 1.32 The owner's son (who also drove the coach) supported the claim that the retarder did not work when leaving the repairer's premises. He said that, while waiting outside a local school some weeks after the pickup date of 2 October 2009, he was talking to another bus driver about the defective retarder. This driver informed him that generally, if the retarder does not work, it is due to a wire that has come adrift either under the dash or on the side of the transmission. While waiting at the school, the son positioned himself under the coach and noted that a wire with a spade connector was disconnected. He reconnected the wire and found the retarder then worked perfectly.

- 1.38 The transmission on the coach was fitted with an output retarder to reduce the demand on the service brakes. The retarder utilised the transmission fluid as a braking medium, using the transmission cooler to dissipate the heat generated by its operation.
- 1.39 In the case of TV3574, the retarder was turned on by means of a switch originally intended to actuate a Jacobs compression release brake (commonly known as a 'Jake brake'). When switched on, the retarder was designed to function automatically, providing retardation when the accelerator was released. On examination, it was found that the switch had been disconnected, as can be seen in *Photograph 5*, and that the electrical connection to the retarder solenoid had also been disconnected, as shown in *Photograph 6*.

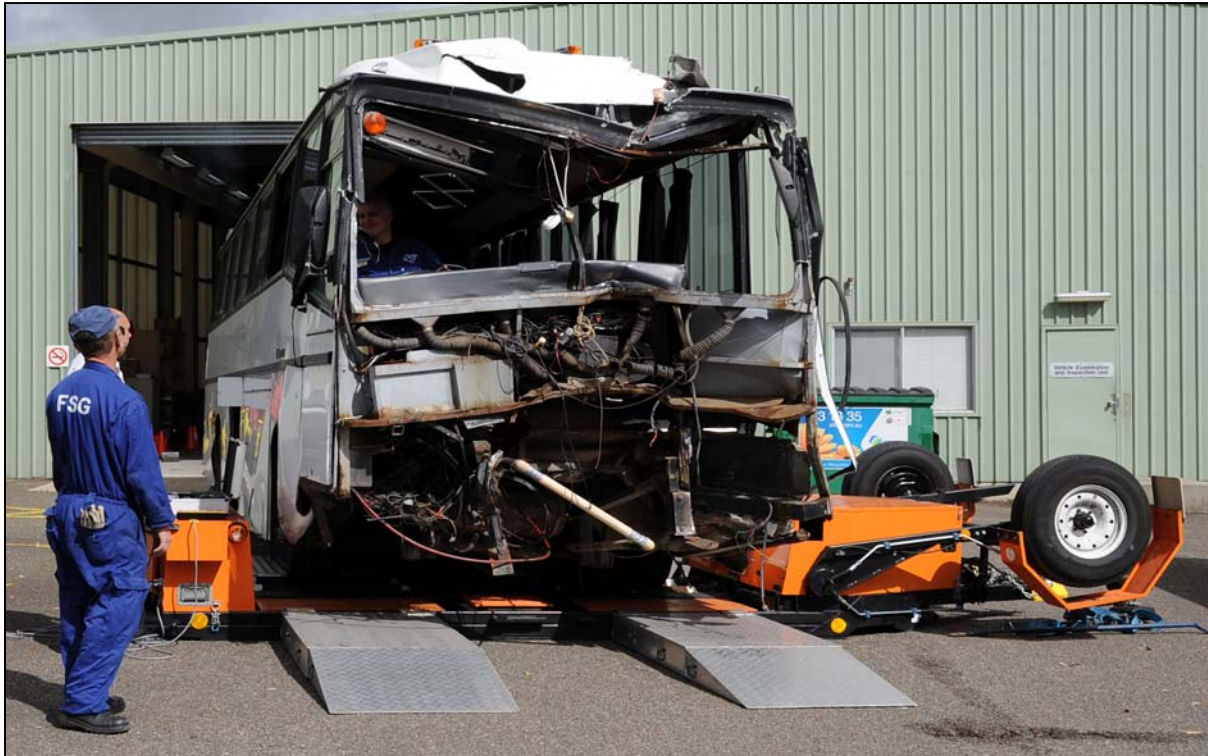
Photograph 7: Coach being placed on RTA VIT

October 2010 Police, RTA, an independent vehicle insurance inspector and OTSI conducted an inspection of the vehicle. The vehicle was tested using the RTA's Vehicle Inspection Trailer (VIT) (see *Photograph 7*), which checks brake balance and effectiveness as well as looseness in the suspension and steering.

- 1.62 The test concluded that the suspension of the vehicle was satisfactory and would have passed the required heavy vehicle inspection scheme (HVIS) testing regime under which all public passenger vehicles seating nine or more passengers must be inspected twice a year by the RTA. However, the test revealed that, although the front brakes were effective and balanced, the rear brakes were severely out of balance by 41%, and so were ineffective. Currently in NSW the maximum allowable imbalance level is 30%.
- 1.63 While the coach was on the VIT the rear brake inspection holes were viewed and photographed. *Photograph 8* shows clearly that there is no brake lining visible through the brake inspection hole. This contradicts the recollection of the examiner at the HVAIS that the coach had ample brake material and braked in a balanced manner when he drove it.

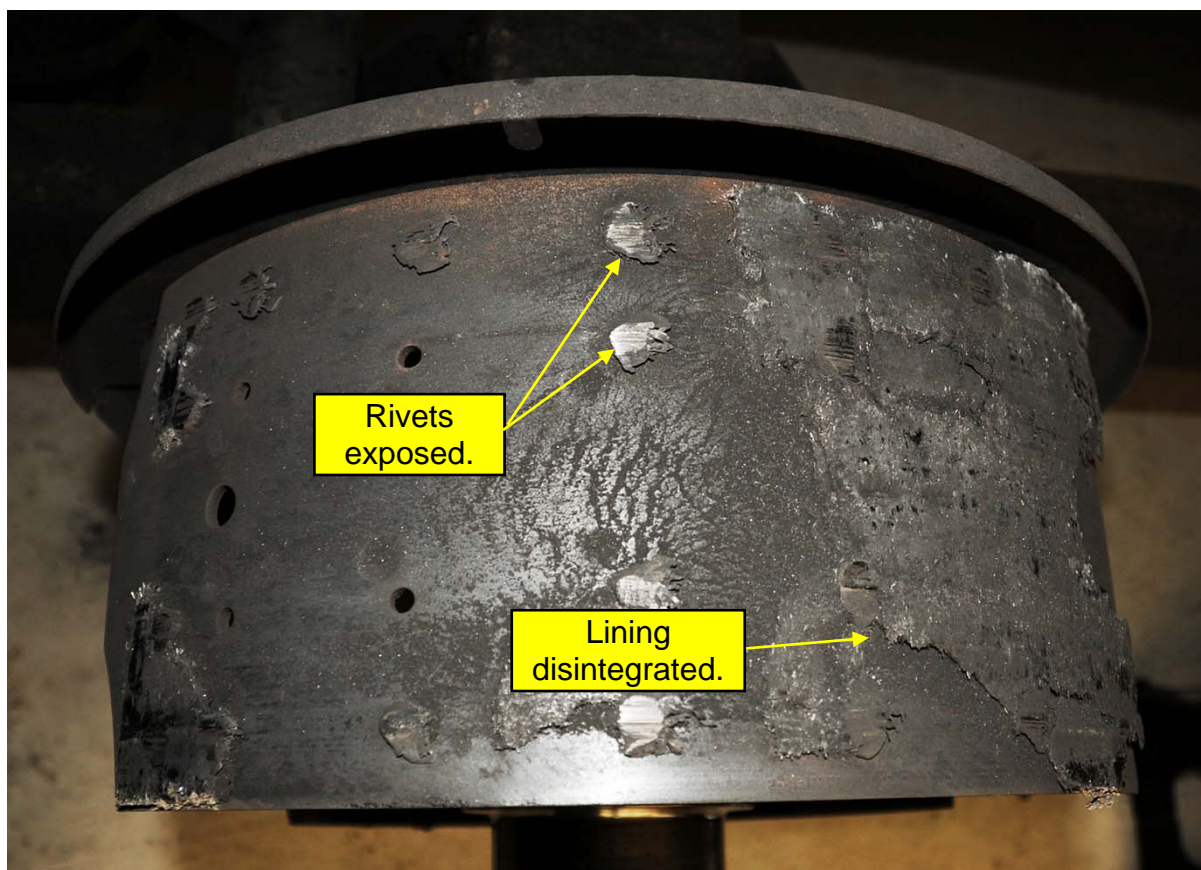
Photograph 9: Rear brake lining disintegration and exposed rivets

- 1.66 On inspection of the rear brakes, it was found that the brake linings had disintegrated so that the rivets had been contacting the brake drum (see *Photograph 9*). Furthermore, the brakes had been over-adjusted so that the S-cams were fully rotated as can be seen in *Photograph 10*, and were incapable of applying any pressure to the brake shoes.

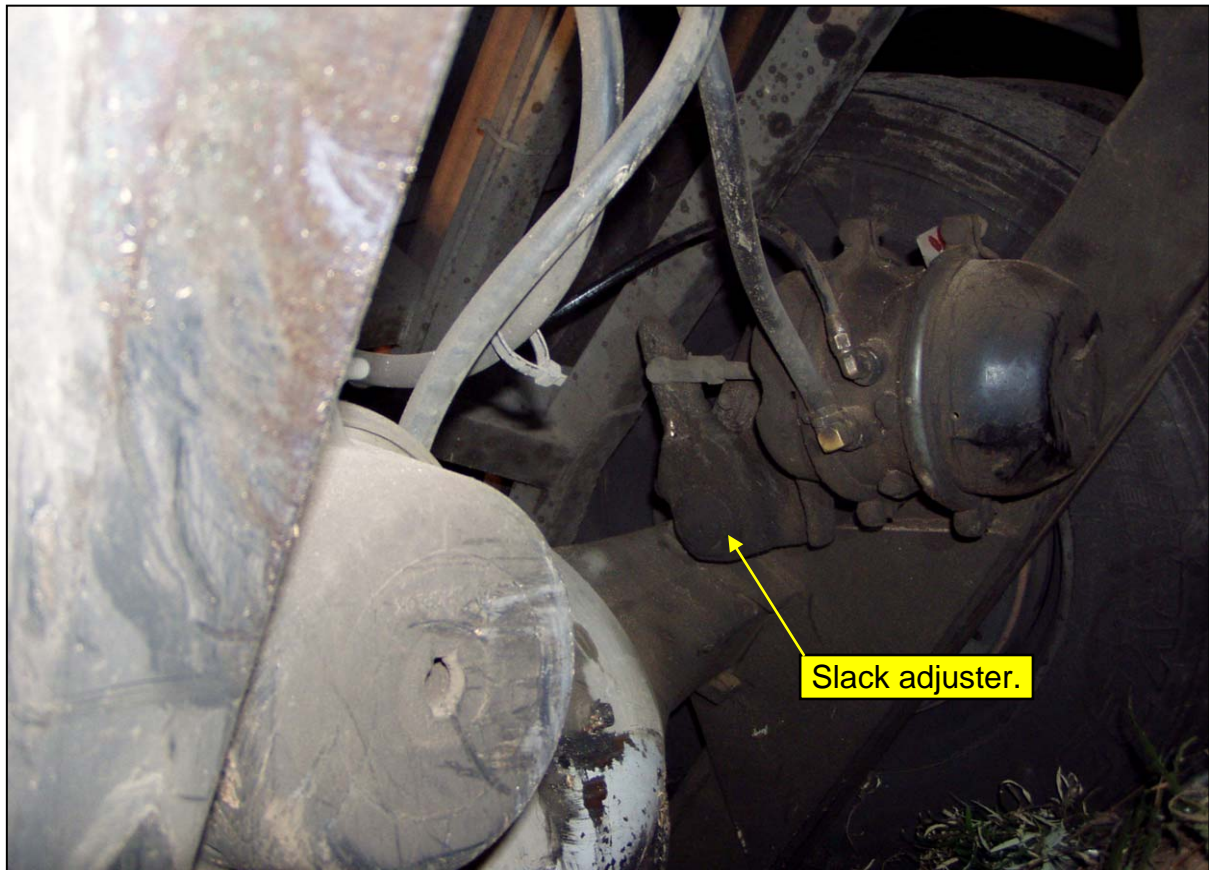
Photograph 11: Condition of brake slack adjuster

- 1.67 The manual slack adjusters at the rear of the brake assembly were found to be covered with thick grime from a combination of grease and dirt (see *Photograph 11*). This indicated the brakes had not been adjusted for a considerable time, contrary to the statements by both the G&S Mini Bus mechanic and the RTA authorised examiner that the brakes had been adjusted several times and were in good order just 11 days prior to the accident.
